Full Condition Survey.

Name of Vessel: Crosby

Yacht, inland waterway and Small Craft Surveyor

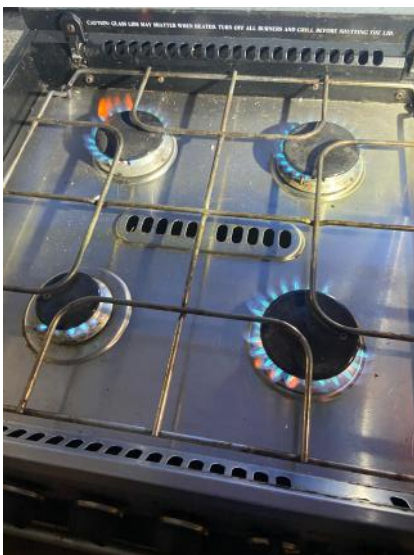
Advise. The cooker hob has a yellow flame and needs servicing

Advise. The cooker hob has a yellow flame and needs servicing
