Survey Report Surv/02202

SURVEY REPORT

On the narrowboat

"Sparkbrook"

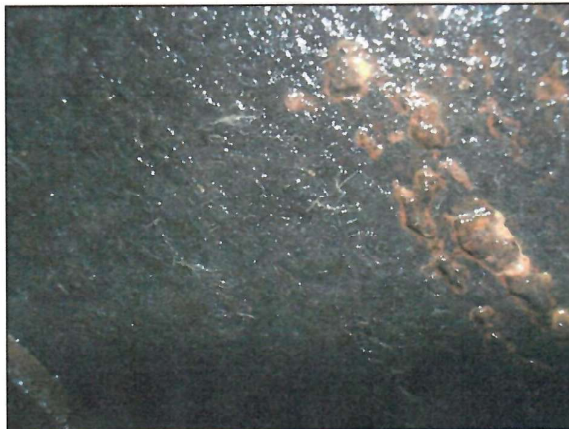
Photograph 3

- 4.4 The bottom plates are typically unpainted and are now lightly fouled and lightly marked with corrosion by-products. The hull side, swim, transom, and counter plating has previously been blacked and is now lightly fouled with marine growth and similarly marked with corrosion by-products, this being more apparent along the waterline where the paintwork is damaged or deteriorated, leaving the steelwork exposed. The hull sides are lightly scuff-marked locally to the forward and aft swim entries.

Bottom plates showing build-up of corrosion by-products.

Recommendation – the narrowboat requires descaling and repainting at this time (P).

Recommendation – consideration should be given to painting the bottom plates (A).

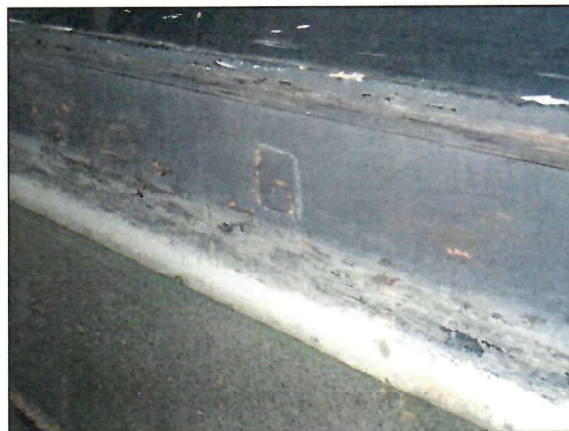
Photograph 4

Hull sides showing scuff marking.

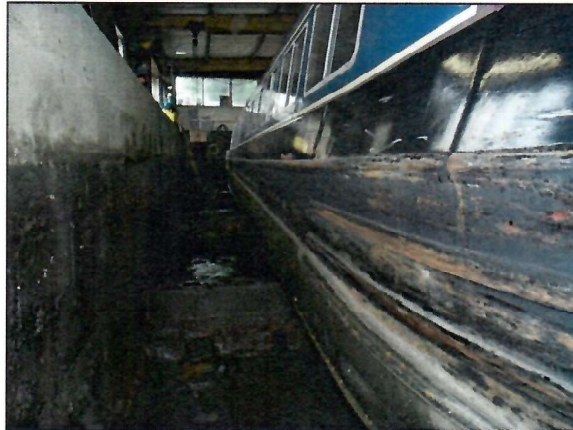
Photograph 5

- 4.8 As noted above, the bottom plates are typically unpainted. The hull side, swim, transom, and counter plating have previously been blacked. The blacking is in fair condition, with scrapes and scuff marks apparent. The hull should be cleaned back and reblacked at this time. Consideration should be given to painting the bottom plating. Consideration should be given to either painting the hull with a compatible metal primer in addition to the blacking, or preferably to the use of either a two-pack epoxy paint system or a proprietary paint system such as Leigh's Paints 'Resistex'.

Hull sides showing scuff marking.

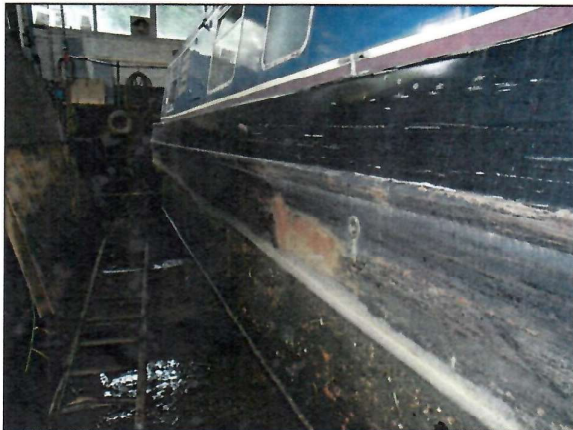
Photograph 6

Hull sides showing scuff marking.

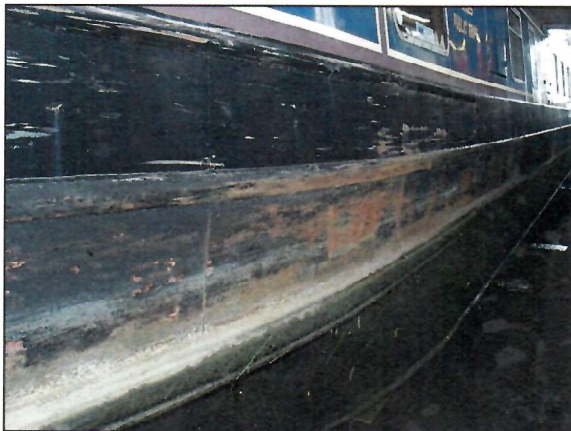
Photograph 7

Hull sides showing scuff marking.

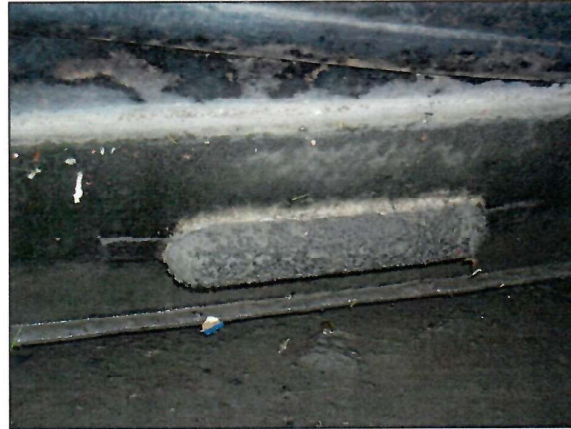
Photograph 8

6.1 The narrowboat is fitted with a total of four sacrificial anodes, these located two forward and two aft. The overall condition of the sacrificial anodes is such that they should remain adequate until the next docking within a two-year period.

Sacrificial anode.

Recommendation – the condition of the sacrificial anodes should be assessed at each docking and replacement sacrificial anodes fitted as found necessary (M).

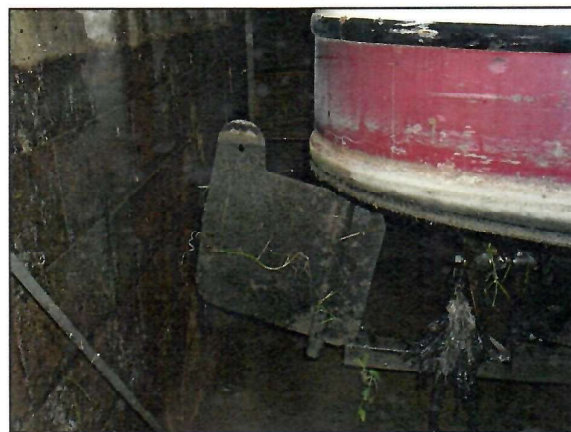
Photograph 9

- 7.1 The steering gear is a conventional arrangement comprising of a balanced flat plate rudder which is connected to a rudder stock and operated by a swan-necked tiller arm from the aft deck.
- 7.2 The rudder is of flat plate construction of nominal thickness 10,0 mm. The rudder plate appears to be of adequate shape, size, and balance. The rudder plate is in poor condition with the connection to the rudder stock damaged.

Rudder plate.

Recommendation – the rudder plate fixing arrangements should be examined and repaired as found necessary (P).

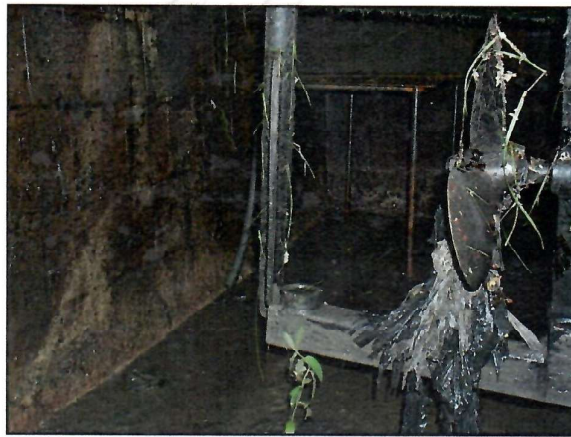
Photograph 10

- 7.4 The swan-necked tiller arm is bolted to a boss which is welded to the rudder stock. The tiller arm is in sound condition.
- 7.5 The rudder upper bearing comprises of a proprietary bearing which is bolted to the aft deck. The rudder upper bearing is in reasonable condition with no play evident. The lower bearing comprises of a steel bush which is welded to the skeg to form a housing for a pintle extension of the rudder stock. The lower bearing arrangements are in sound condition.

Rudder lower bearing arrangement.

Recommendation – the condition of the rudder lower bearing arrangements should be checked when the rudder stock is repaired (P)

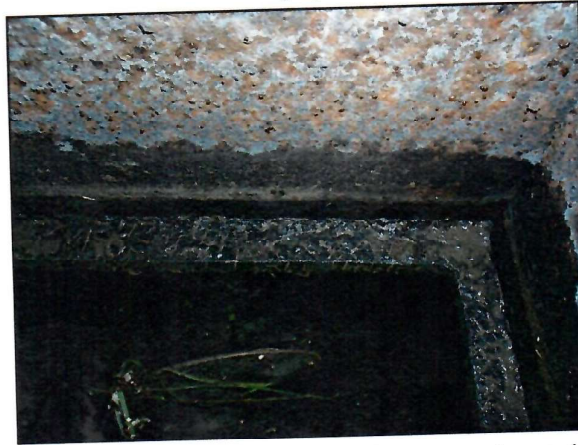
Photograph 14

- 8.4 The weed hatch trunk is in reasonable condition, showing signs of light pitting and surface corrosion but appearing to remain adequate at this time.

Weed hatch trunk – note the surface corrosion and light pitting.

Recommendation – the weed hatch trunk should be descaled, closely inspected, and repainted at this time (P).

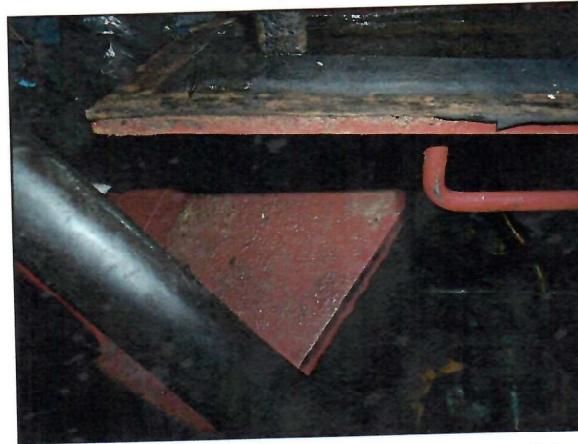
Photograph 15

- 8.5 A neoprene rubber strip gasket is bonded to the underside of the cover plate. The gasket is in poor condition and will not be effective in providing a seal between the cover plate and the upper perimeter flange.

Weed hatch gasket – note the poor condition of the gasket.

Recommendation – a new weed hatch gasket should be fitted at this time (P).

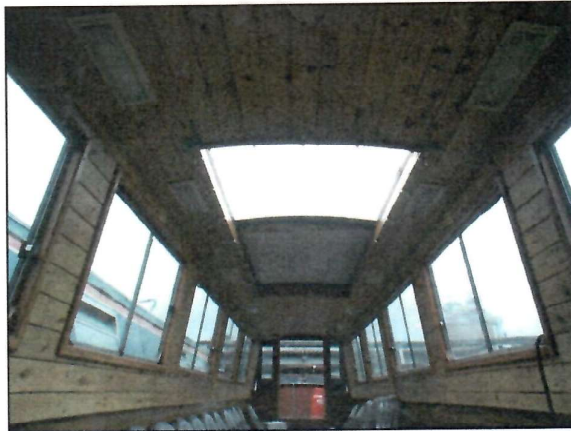
Photograph 17

- 11.2 The sliding hatch of size 865 mm by 3 m is fitted in the cabin roof. The hatch appears to be in sound condition but is difficult to operate and is not provided with a means of securing.

Coach roof sliding hatch.

Recommendation – the operation of sliding roof hatch should be improved (P).

Recommendation – the sliding roof hatch should be fitted with a means of securing when closed (P).

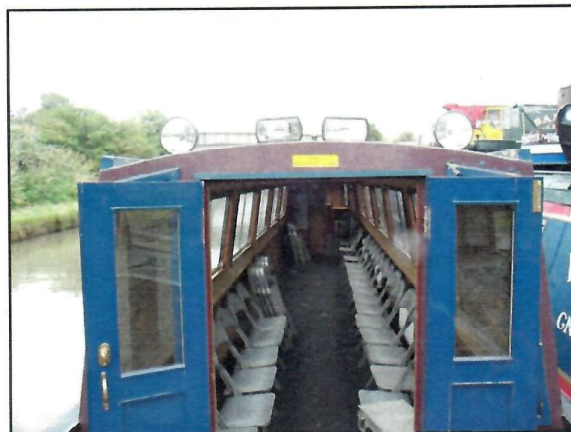
Photograph 18

- 11.3 The forward bulkhead is fitted with double hardwood doors and side windows. The side window panes are not marked to indicate the grade of glass in use – the Boat Safety Scheme requires glazing materials to conform to BS 952: Part 1, or to be of suitable acrylic or polycarbonate material. The doors are in sound condition; however, the starboard door is not protected by paint along the hinged edge. The doors appear to be secure when closed with a dead lock and bolt providing security.

Cabin forward doors.

Recommendation – the grade of the glass in the cabin forward doors should be verified, or the glass replaced either with glass conforming to BS 952 Part 1, acrylic sheet, or with polycarbonate sheet (A).

Recommendation – the hinged edge of the starboard forward door should be painted (A).

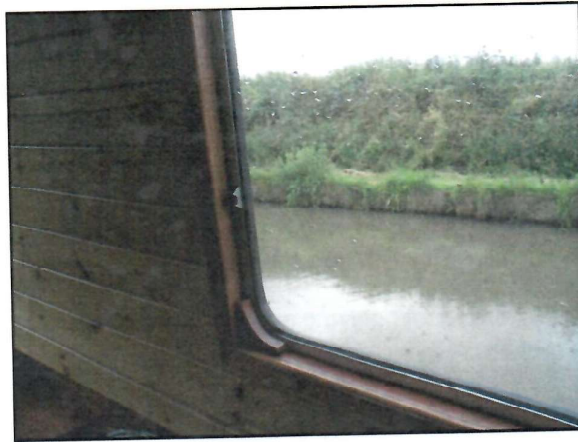
Photograph 19

- 11.4 Doors and hatches are fitted in the cabin sides to port and starboard. The doors are of steel construction with wooden linings internally. The doors are in sound condition. The doors appear to be secured when closed and locked.
- 11.5 Doors and a hatch are fitted in the cabin aft bulkhead. The doors are of steel construction and are in sound condition. The doors appear to be secured when closed.
- 11.6 Aluminium -framed hopper style sliding windows are fitted to the cabin sides in the main cabin, with top-opening windows fitted in the galley. The windows are in poor condition with catches and seals missing. The windows appeared to be leak-free at the time of the survey; however, the existing seals are showing signs of deterioration. The window panes are not marked as being of an appropriate grade of toughened glass.

Cabin window – note the missing catch.

Recommendation – the missing window catches and seals should be replaced (P).

Recommendation – the grade of glass in the windows should be verified, or the panes replaced with toughened or safety glass (P).

Recommendation – the windows require re-sealing (P).

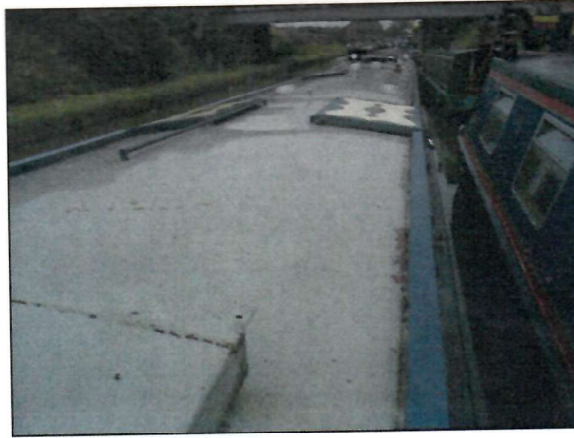
Photograph 20

- 12.1 The narrowboat is painted with a bitumen-type paint to the hull sides up to the upper full length rubbing strake, and maroon gloss to the upper hull sides, gunwales, cabin side, bulkheads, and decks. The cabin roof is painted grey. The cabin sides are decorated with blue panels and cream borders. Refer to comments above regarding the deteriorated condition of the hull blacking. The gloss paintwork is in poor condition and requires repainting at this time.

Cabin roof showing deteriorated paintwork.

Recommendation – the narrowboat requires repainting (P).

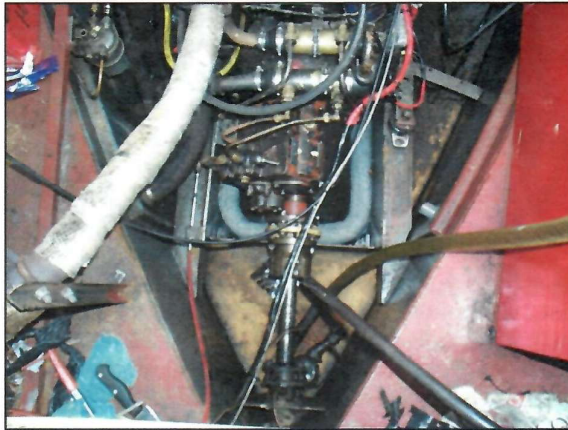
Photograph 29

- 14.7 The engine is fitted with a water jacket manifold exhaust system which comprises of a solid section connected to a silencer box which discharges through a port side hull outlet. The exhaust system is fully lagged. The exhaust system appears to be in sound condition (the lagging has not been removed to allow for close inspection of the system) and to be leak-free.

Engine exhaust system.

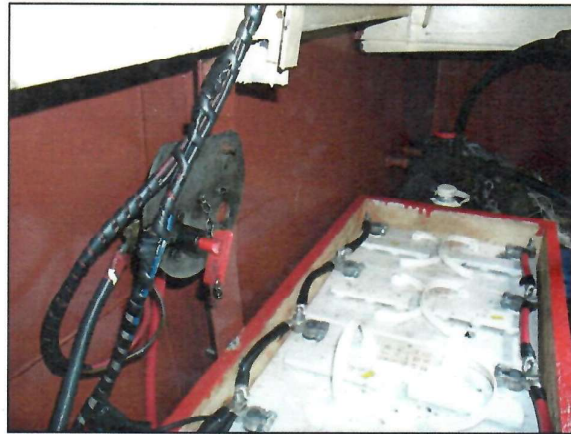
Photograph 32

Battery bank with cover removed, and battery isolation switch.

- 17.5 The batteries vent directly into the engine space – this arrangement is not satisfactory in that the engine space is not adequately ventilated – refer to comments above in this respect.
- 17.6 The battery bank is isolated on the positive circuits by means of a key-operated battery isolation switch. The battery isolation switch is located above the batteries. The location of the battery master switch is identified by means of a label located above the aft deck. The isolation switch is in sound condition and appears to be capable of isolating all the 12-volt circuits.
- 17.7 The battery cables are secured by means of crimped cable connectors which are attached to stud type battery terminal blocks. The battery terminal connections are in reasonable condition with traces of light corrosion apparent to several of the terminal blocks. The

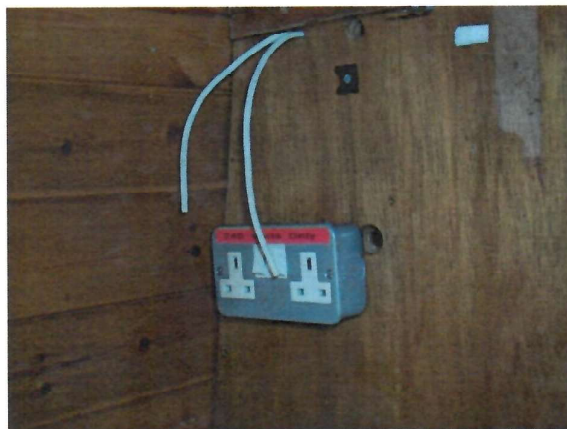
Photograph 33

Unidentified and unconnected cables.

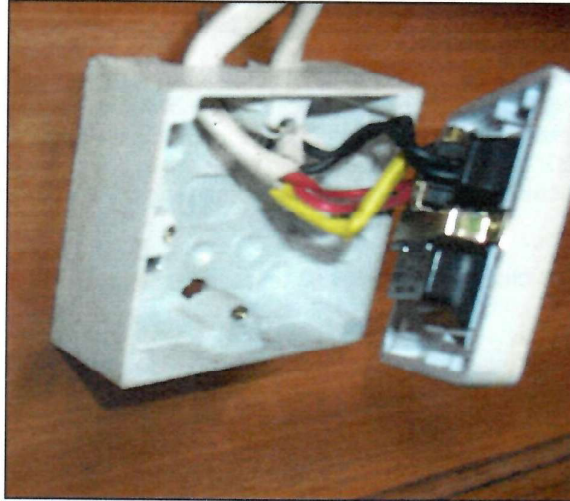
Photograph 34

Socket removed to show the use of domestic grade cables.

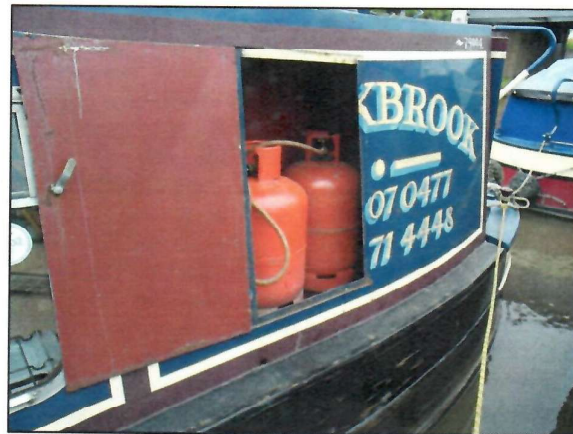
Photograph 35

Gas locker.

- 19.3 The gas locker is vented at low level by means of a slot cut into the locker side immediately above the locker base. The gas locker is adequately vented at high level by virtue of the latent gaps which exist around the locker cover.
- 19.4 No means are apparent for securing the gas cylinders (this is a Boat Safety Scheme fault item).

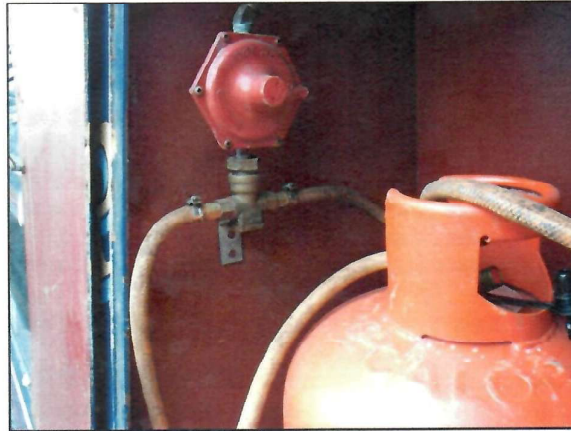
Photograph 36

Calor 766 gas pressure regulator – note the use of worm drive hose clamps on the high pressure hoses.
