Hull only report for **Tranquelo**

for [REDACTED]
on the
22nd of November 2025

This survey was carried out on the 22nd of November 2025 at Stoke On Trent Boat Building Marina the Above being the owner.

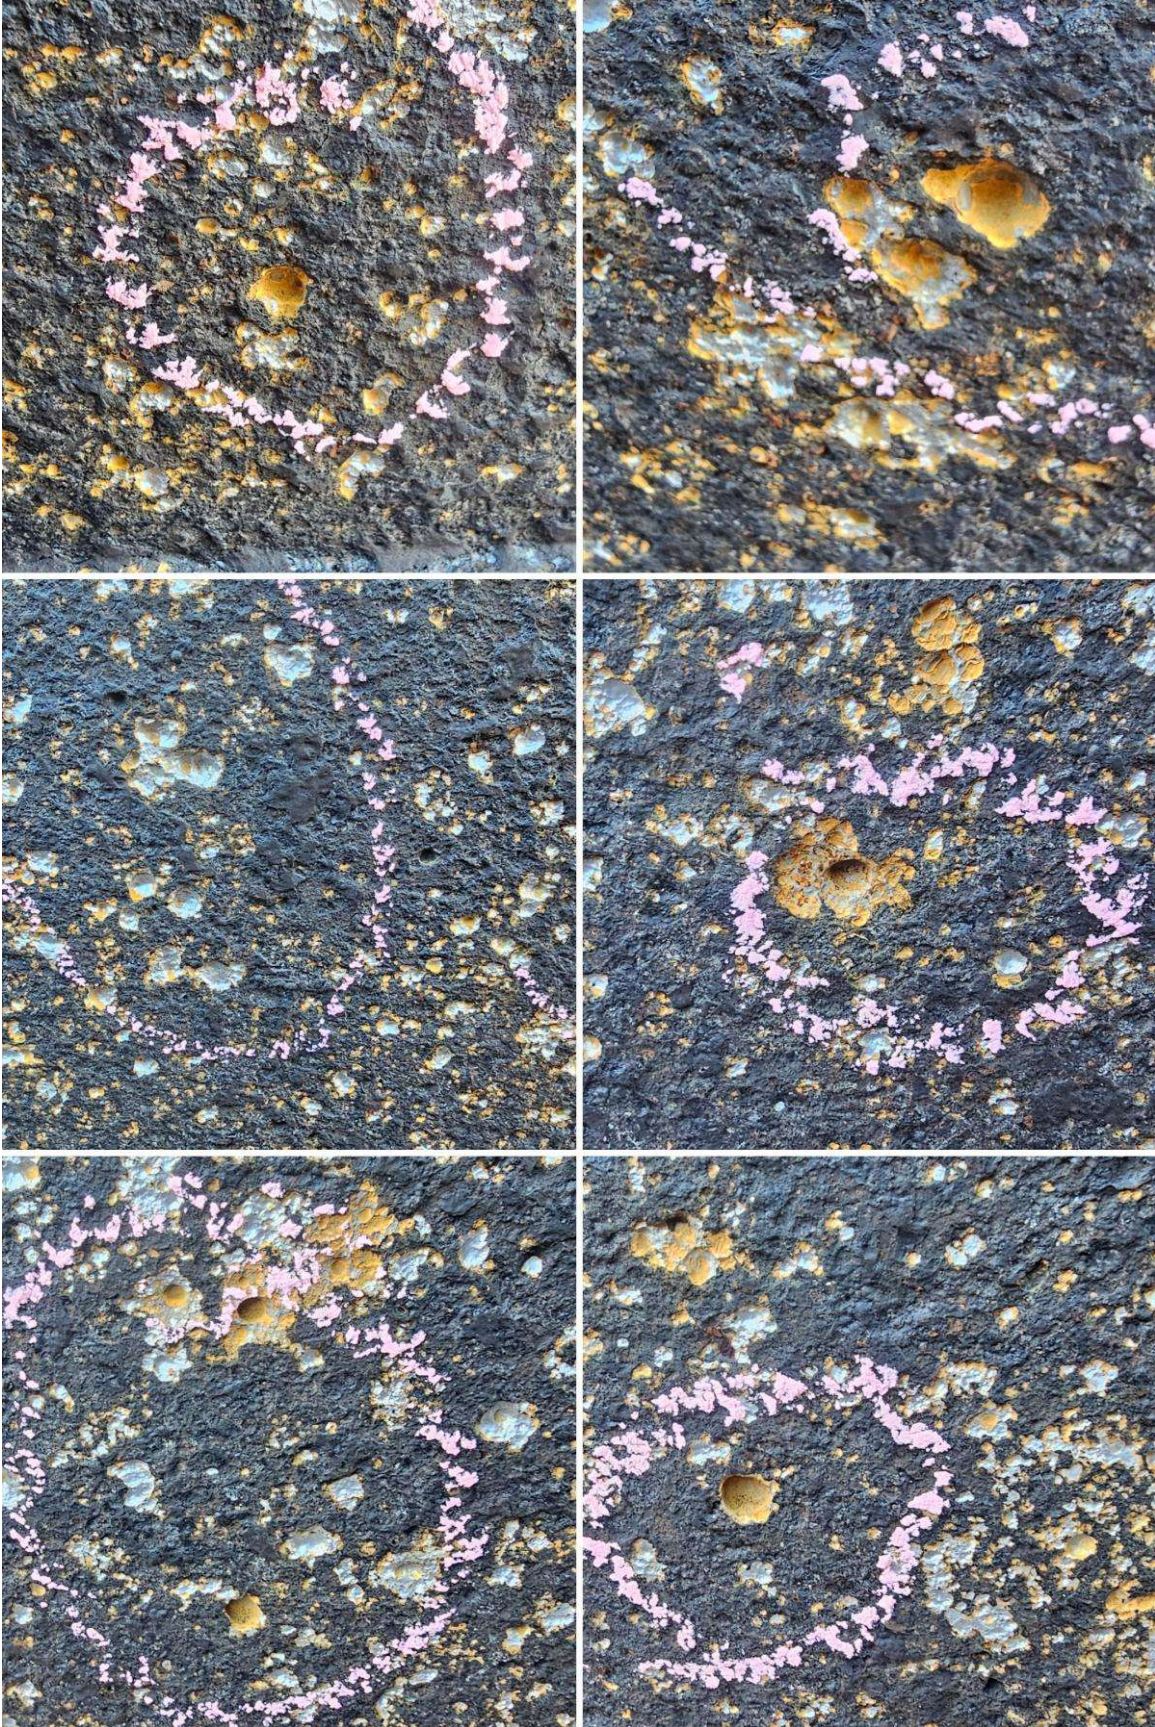
The hull sides were **pressure washed** thoroughly to remove surface deposits and enable an effective visual and ultrasonic inspection. Thickness measurements were taken systematically along the **waterline** and **chine**. Readings ranged from **6.0 mm to 4.5 mm**, with the lowest recorded value of **4.5 mm** located on the **starboard side, Section 7**, at the waterline.

A visual examination revealed **widespread areas of both light and deep pitting** across the hull sides. Pitting depths measured between **1 mm and 4.5 mm** on plating of **5.9 mm** original thickness. Several of these pits represent significant material reduction requiring attention.

- **Grit blast the hull sides to bare metal to fully expose the extent of pitting and corrosion.**
- **Puddle weld all pits greater than 3 mm in depth to restore plate integrity.**
- **Once repairs are complete, treat the hull sides with a marine-grade two-pack epoxy resin coating system to provide long-term corrosion protection.**

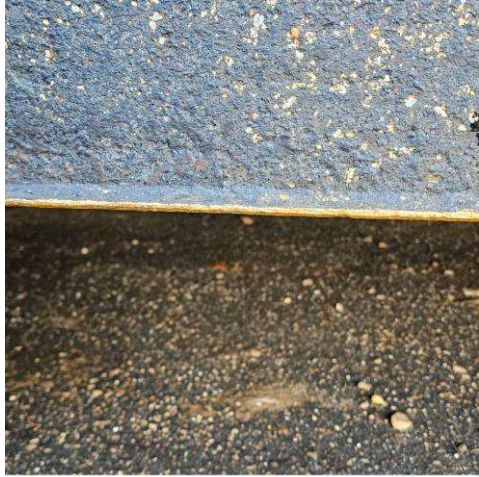
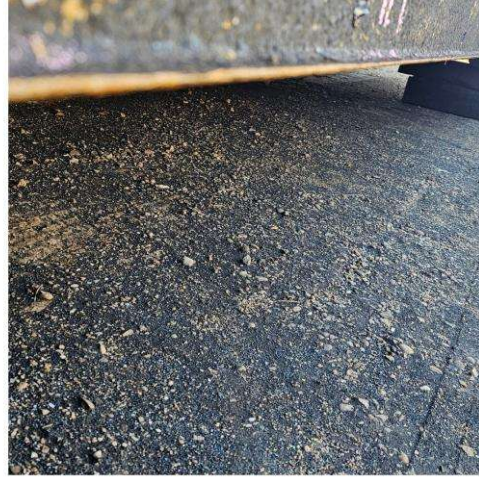
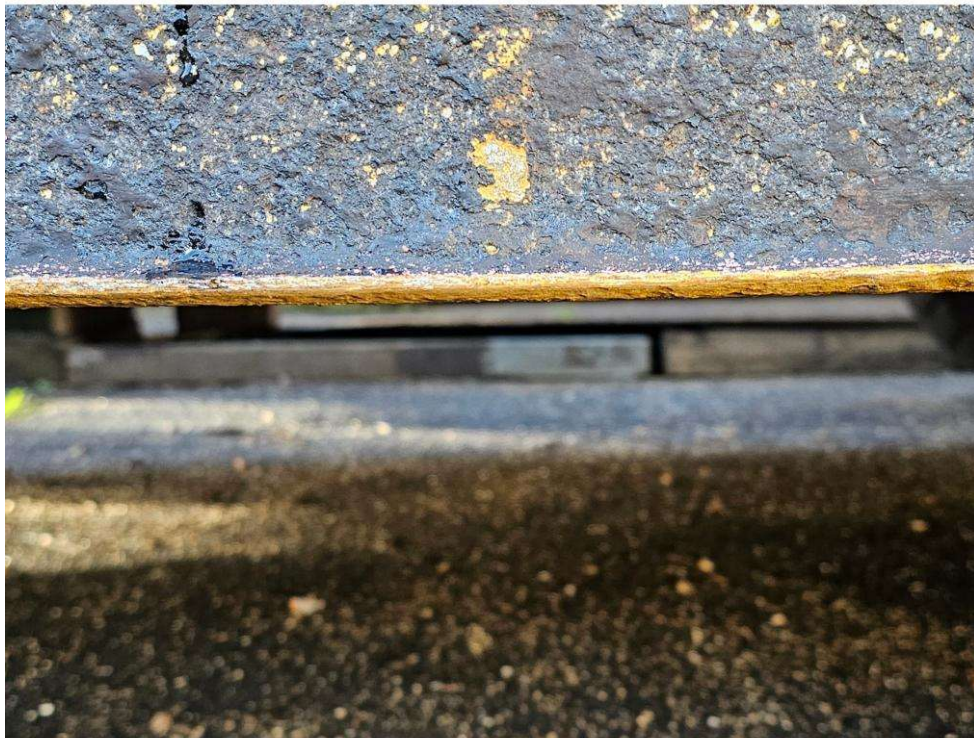
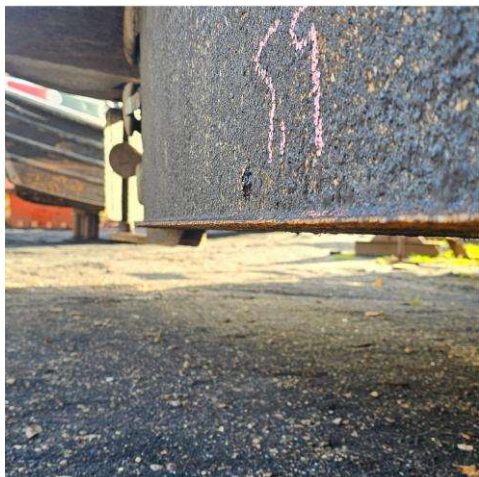
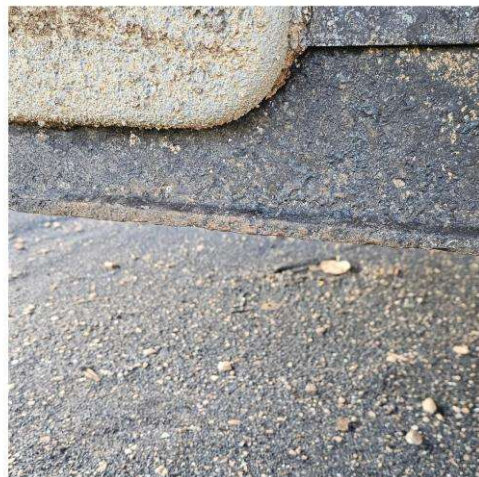
Selective areas of the base plate were **cleaned back to bare steel** to allow for inspection. The base was heavily coated in mud, and several areas showed visible surface rust. The original base plate thickness is **10 mm**.

Ultrasonic thickness readings taken along the **centreline** ranged from **8.0 mm to 10.0 mm**, with visible pitting between **1 mm and 3 mm** in depth. These pitted areas still retain adequate remaining thickness and are considered structurally sound.

However, thickness readings taken approximately **200 mm inboard from the edges** of the base plate ranged from **2.5 mm to 5.0 mm**, with pitting depths of **1 mm to 3 mm**. These readings indicate **significant material loss**, leaving these edge sections with **very low remaining steel thickness**.

The **wear edge** of the base plate was also found to be heavily thinned, with some sections reduced to **approximately 2 mm** in thickness. This level of deterioration is consistent with prolonged abrasion and edge wear.

- **Grit blast all affected areas of the base plate to bare metal to fully expose the extent of corrosion, pitting, and wear.**
- **Fully weld 6 mm × 200 mm mild steel plates along the straight sections of the vessel's base to reinforce the low-thickness areas and restore structural integrity.**
- **Fit and fully weld additional 6 mm plating around both stern corners to protect these high-wear zones and compensate for the reduced plate thickness.**
- **These welded plates will also serve as a new sacrificial edge, replacing the worn original and providing ongoing protection against abrasion and impact.**

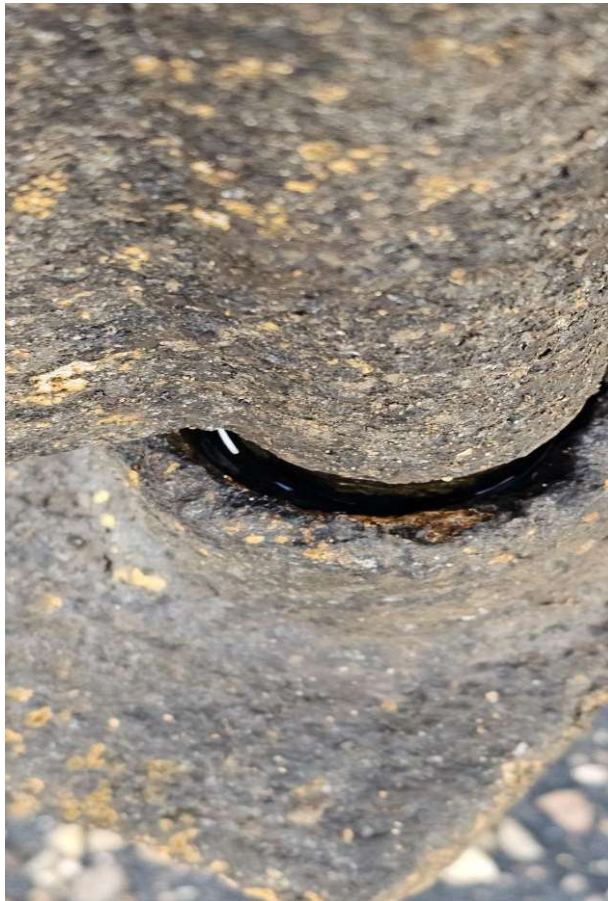
The **rudder cup** was found to be in **poor condition**, with noticeable play present in the lower rudder support, indicating wear and reduced effectiveness of the bearing surface.

- **Replace the rudder cup to eliminate play and restore proper support for the rudder stock.**

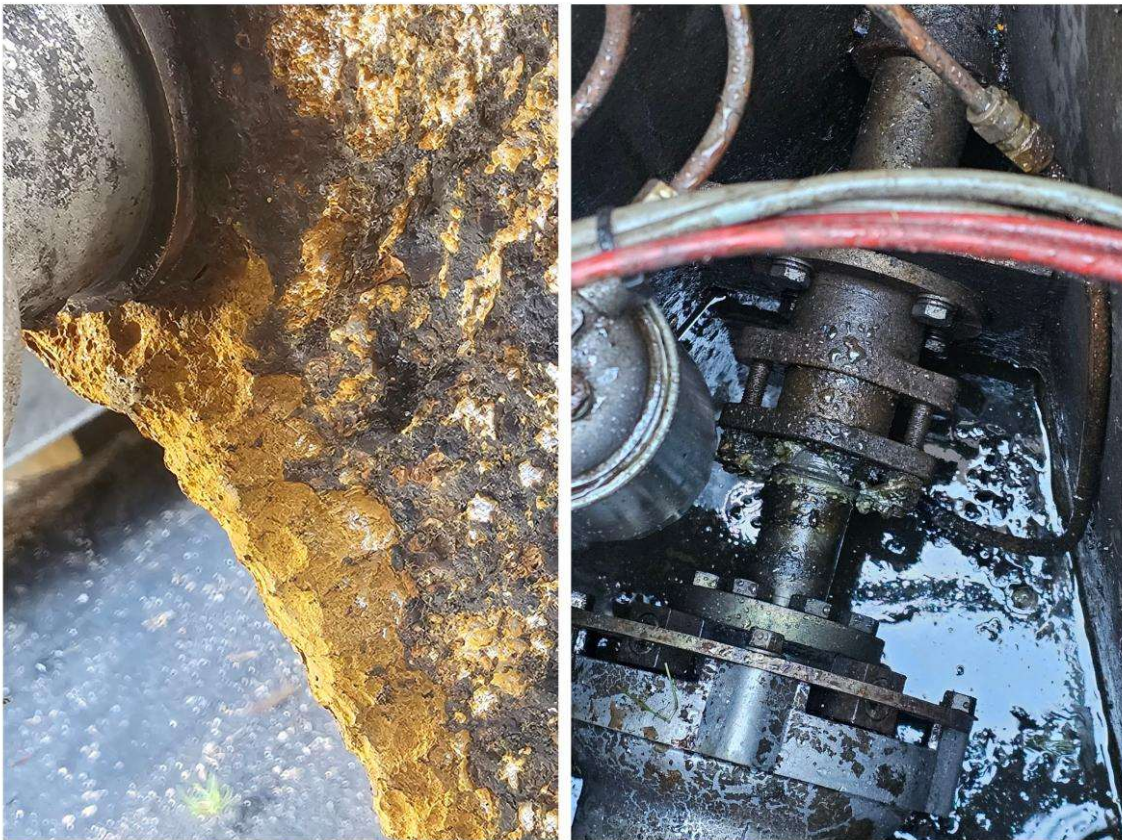
The vessel is fitted with a 1½-inch propeller shaft running through a **brass cutlass bearing**. The bearing was found to be in poor condition, with excessive signs of wear. **Evidence of water ingress or dripping** was observed at the time of inspection, indicating that the stern gland and associated components are **not** performing effectively.

- **Replace Stern gear**
