Vessel Name

Too Doo

Survey Dates: July 1st, 2021 & April 4th, 2022 updated on October 28th, 2022

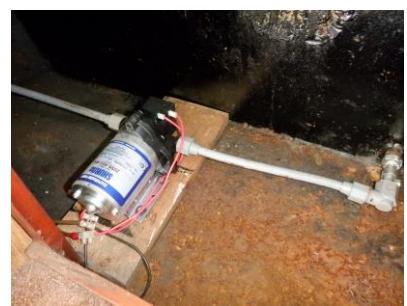
No areas of significant corrosion was found inside the bow but slight surface corrosion was found on the top of the base plate adjacent to the freshwater pump just aft of the freshwater tank. See picture on the right

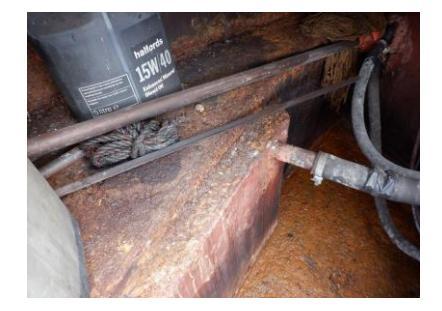
Extensive surface corrosion was found in all areas of the engine bay, see picture on the right.

Remove the surface corrosion in the engine bay including on the engine cooling tank connections and apply a suitable corrosion protective coating.

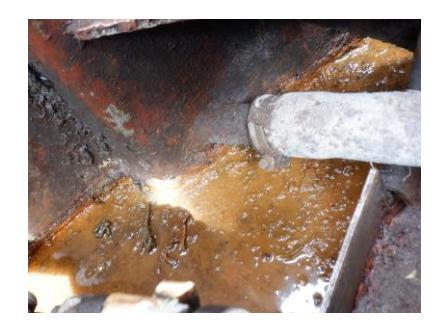
The engine cooling system tank on the port side of the engine bay was badly affected by surface corrosion. The cooling system tank upper connection is shown on the right.

Extensive surface corrosion was found on and around the engine cooling system tank lower connection – picture on the right.

Note the extensive surface corrosion on the engine cooling system tank connections is a serious cause for concern as leaks from these connections can cause engine overheating and damage in addition to adding to the corrosion in the engine bay. Remedial action should be taken as soon as possible.

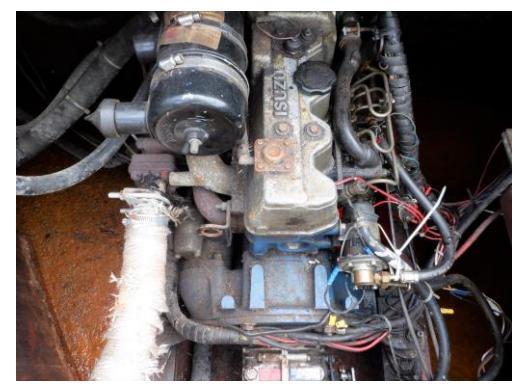
The engine running hour meter was not working. The engine started easily and ran normally during a 10 minute running test. The engine temperature remained in the normal range, no evidence of major damage or trauma and no leak paths were found on the engine or the fuel or exhaust pipe work. Inspection showed that the engine fuel and exhaust pipe work and fixings were sound and the engine mountings secure. Surface corrosion was found on the engine but it appeared to have been reasonably well maintained.

No damage was found on the Matrix Controls Ltd engine control panel and the single lever engine control worked normally.

Note: The surveyor is a not a marine engine specialist, an engine survey was not carried out. If no professional engine service records and available and continuous cruising is planned it would be prudent to have the engine inspected / serviced.

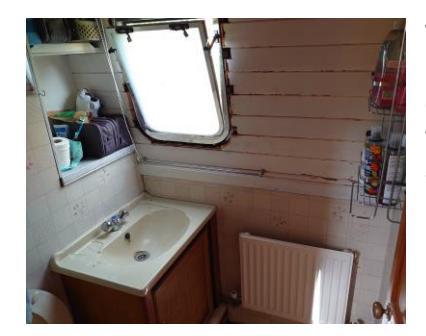
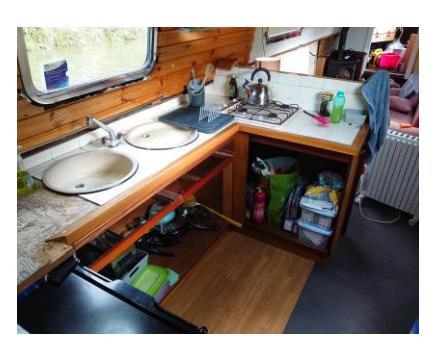
The internal fixtures and fittings were win poor condition, an extensive refit and equipment upgrades are needed to bring the boat up to today's normally accepted standards

Note It was reported that a complete internal refit is currently underway.

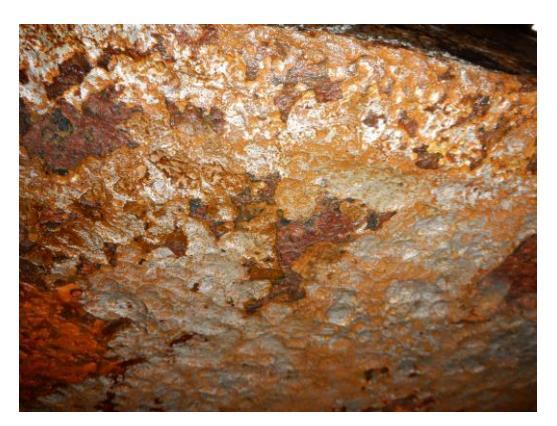
Extensive silver coloured pitting was found on the base plate - see picture on the right. The pits were between 5 and 30 mm in dimeter and from 0.2 to 1.0 mm deep.

Note The extensive silver coloured pitting on the sides and base below the water line indicates that the boat has suffered from the effects of stray electrical current in the water surrounding it. This can be caused by the faults in the 12 or 240 volt electrical systems, faults in an adjacent boats electrical systems or faults in the shoreline supply system. Remedial action should be taken now to avoid serious pitting affecting the structural integrity of the hull

Test the 12 and 240 volt electrical system for leakage and consider commissioning an in the water electrical leakage survey

Attach 2 equally spaced anodes to each side below the water line
