Survey Report Surv/02202

SURVEY REPORT

On the narrowboat

"Sparkbrook"

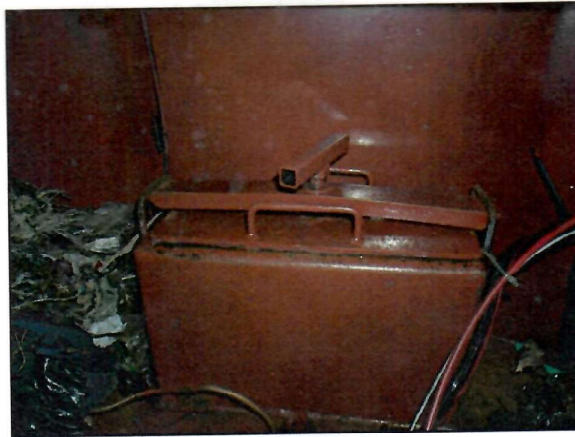
Photograph 11

- 8.1 A weed hatch is fitted in the counter plates directly over the propeller. The weed hatch comprises of a raised trunk and an upper perimeter flange which is closed by means of a flat plate cover and secured by means of a quick-release mechanism. Access to the weed hatch is good.

Weed hatch.

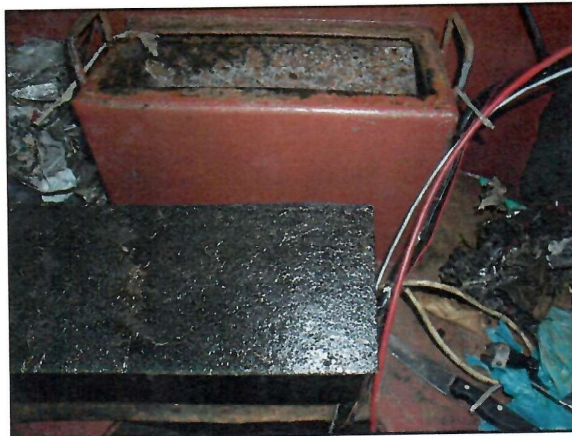
Photograph 12

- 8.2 The weed hatch cover plate is secured by means of a quick-release mechanism which comprises of a cross bar with a central tee stud. The cross bar and the tee stud are sound condition.
- 8.3 The cover plate is in sound condition

Weed hatch with cover removed.

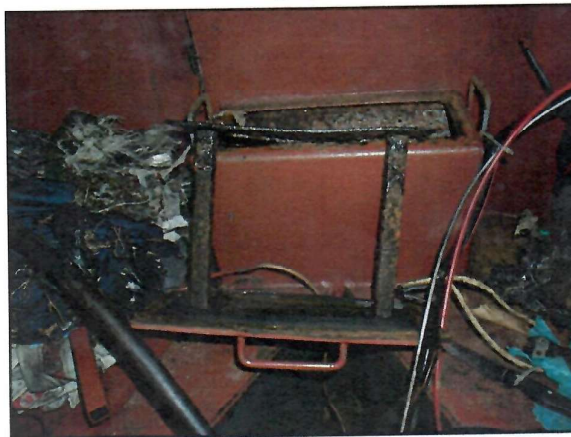
Photograph 13

Weed hatch cover plate and integral splash plate upended.

- 8.6 An integral splash plate is welded to the underside of the cover plate. The splash plate is in reasonable condition, requiring descaling and repainting.

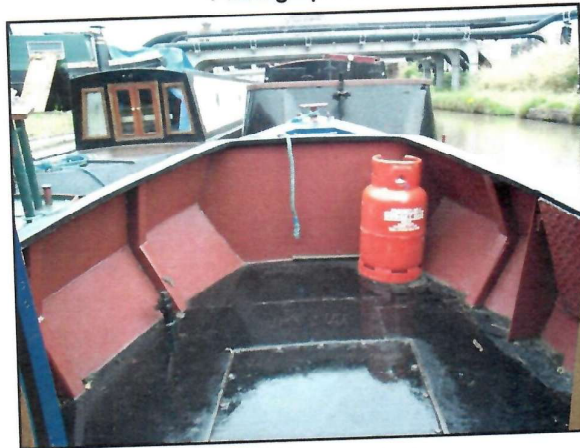
Photograph 16

- 10.2 A self-draining well deck is situated immediately forward of the cabin bulkhead. The well deck is in sound condition. Drain apertures are fitted to port and to starboard in the hull sides adjacent to the cabin bulkhead; the apertures are adequate sized to shed water from the deck.

Foredeck and well deck.

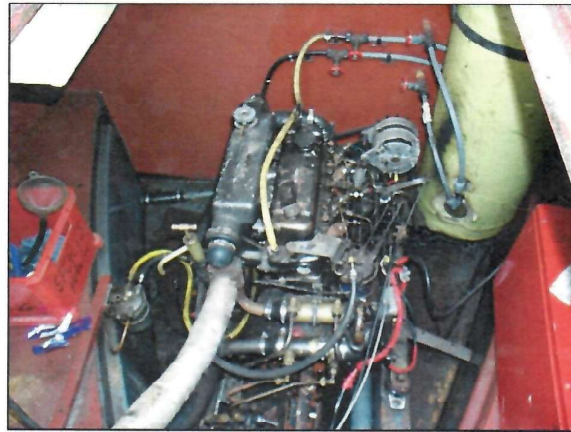
Photograph 28

Engine installation.

- 14.2 The engine and gearbox have not been opened up for examination. The engine oil level is satisfactory. The cooling water level is low; the antifreeze concentration has not been checked. The gearbox oil level is low.

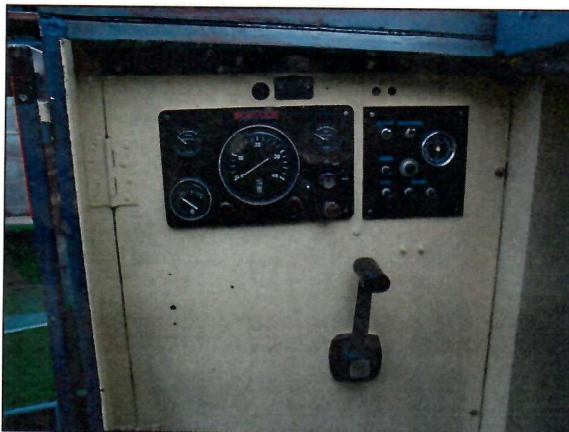
Photograph 30

M & M Marine single lever control and instrument panel.

Recommendation – the control system should be checked and the loose lock nuts tightened (P).

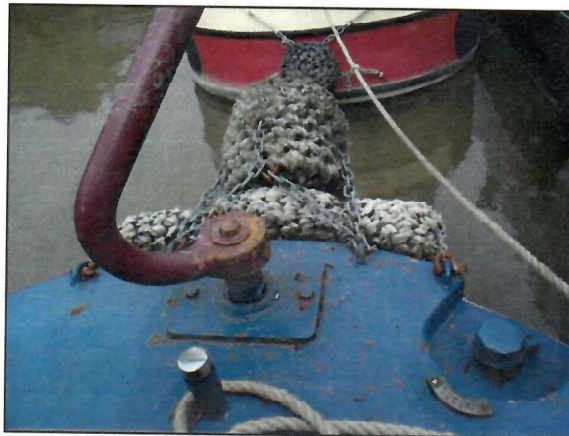
Photograph 31

Fuel tank filling & venting arrangements.

15.3 The fuel tank is vented by means of a stub pipe which terminates on the aft deck immediately forward of the tiller. The vent pipe is connected directly to the fuel tank. The stub pipe is fitted with a gauze flame arrester. The flame arrester fitting is in fair condition cosmetically but remains adequate at this time.

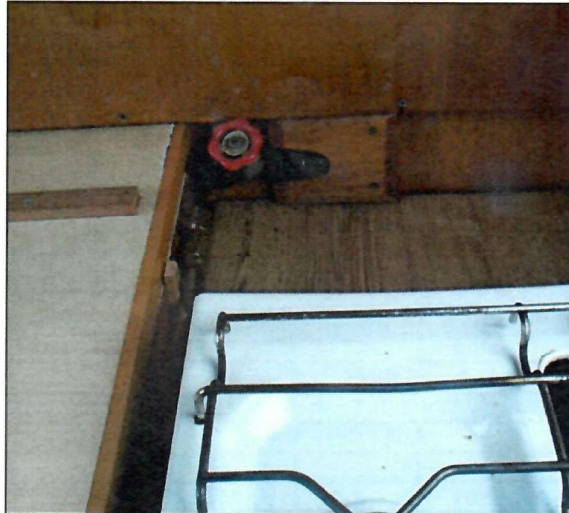
Photograph 37

- 19.9 The gas-burning appliances are connected to the gas feed pipe by means of in-line gas isolating valves and fixed copper pipework. The appliance connection is in sound condition.

Cooker gas connection.

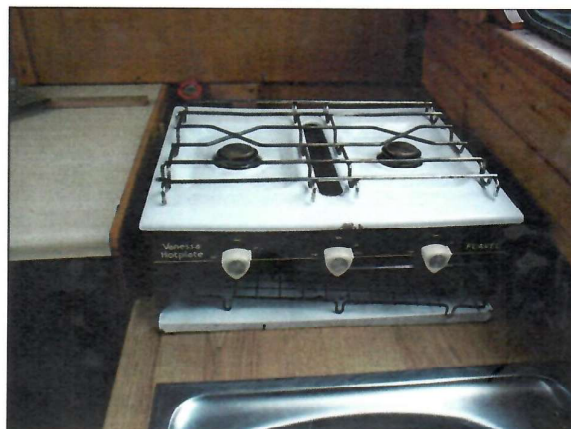
Photograph 38

20.2 The Vanette Vanessa cooker is installed in the galley. The cooker is adequately secured to prevent tipping. The adjacent cabin linings are protected from heat damage. The cooker is in sound condition and appears to function in a satisfactory manner.

Vanessa cooker.

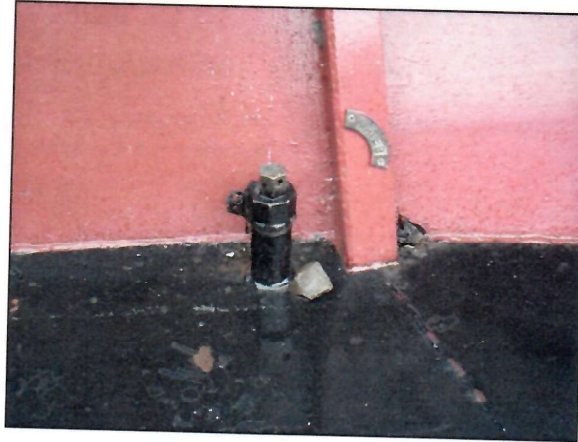
Photograph 39

Water tank filling and venting arrangements.

Recommendation – the water tank access hatch should be removed to allow for inspection of the water tank (P).

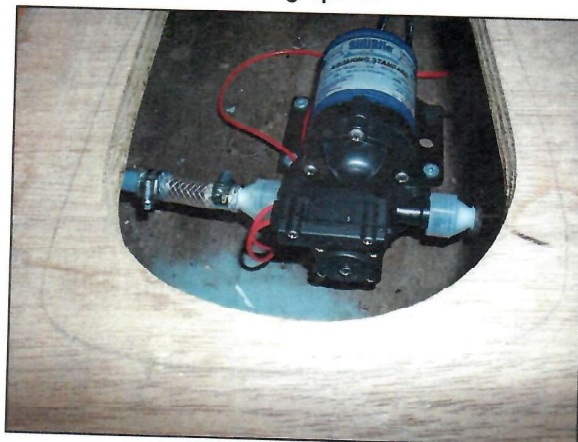
Photograph 40

- 22.2 The water system is pressurised by a means of a Shurflo 12-volt pump. . The operation of the pump has not been verified.

Shurflo water pump.

Recommendation – the operation of the water pump should be verified (P).
