Vessel Name

Too Doo

Survey Dates: July 1st, 2021 & April 4th, 2022 updated on October 28th, 2022

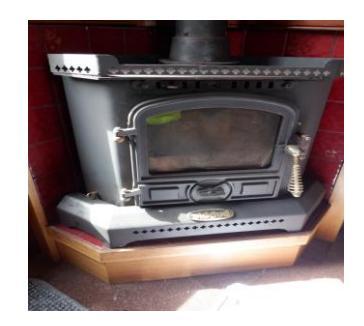
A Bubbles solid fuel room heater was securely located in the lounge area. No physical damage was found on the heater of flue pipes and no signs of water ingress or flue gas leaks were found.

The heater appeared to have been recently installed, it was not tested during this survey.
